Manhole Inspection Summary

Manhole # S41W1_003MH

Location Address: **3501 6th St**

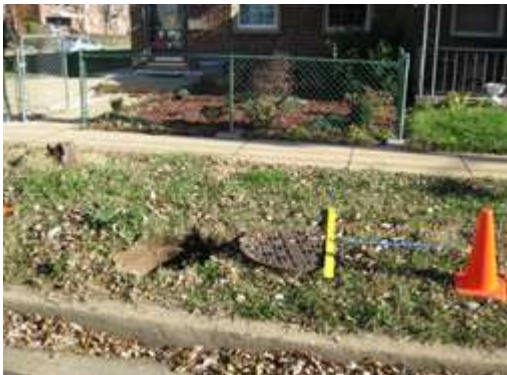
Location View

3501 6th Street

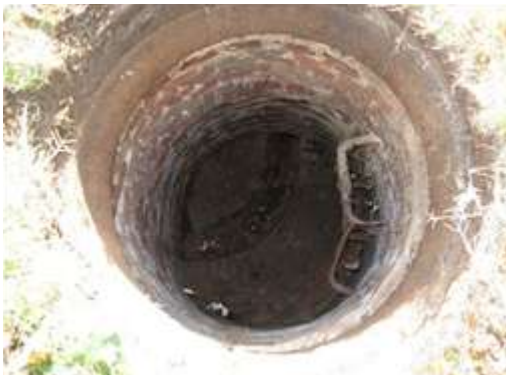
Top View

steps

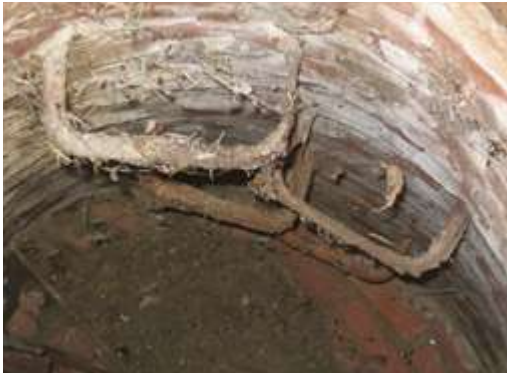
Defect 1

debris

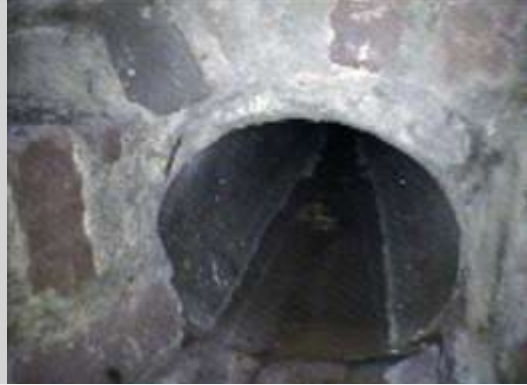
12 O'Clock Outflow

8 in. Circular Gravity Sewer
Pipe Out @ 12 O'Clock

Pipe Height: **10.8** (in.) Rod and Bar (Angled)
Pipe Material: **Clay** ☐ Pipe Lined
Invert Depth: **8.96** (ft.) Flow Characteristics: **None**
Deposits: ☒ None ☐ Mud ☐ Sludge ☐ Debris ☐ Grease
Silt Depth: (in.) Deposits Extent:
Infiltration: **None** Pipe Seal Cond: **Sound**

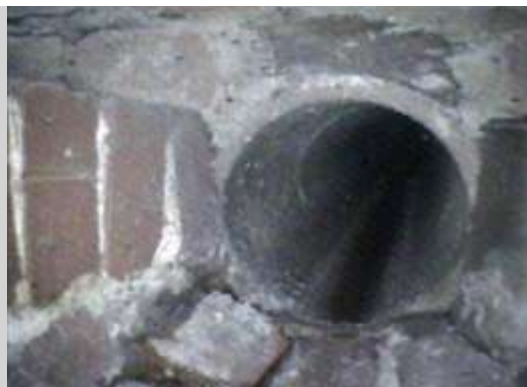
9 O'Clock Inflow

6 in. Circular Service Sewer
Pipe In @ 9 O'Clock

Pipe Height: **6** (in.) Rod and Bar (Angled)
Pipe Material: **Clay** ☐ Pipe Lined
Invert Depth: **8.38** (ft.) Flow Characteristics: **None**
Deposits: ☒ None ☐ Mud ☐ Sludge ☐ Debris ☐ Grease
Silt Depth: (in.) Deposits Extent:
Infiltration: **None** Pipe Seal Cond: **Sound**
